## Identification Of Damage Levels Of Residents' Houses Due To Earthquake in Pasaman 2022

### Abstract

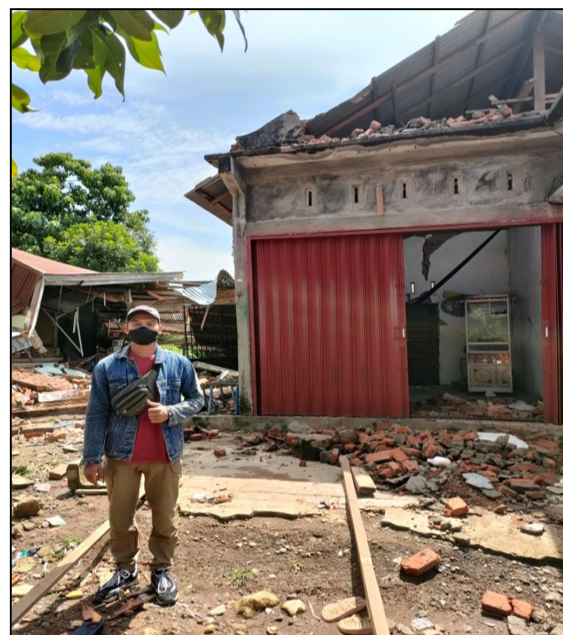
Figure 2. Damage to buildings due to the 2022 Pasaman earthquake

Structures can be grouped into non-engineered and engineered structures. Non-engineered structures are simple buildings designed without structural experts, while engineered structures are structures that are well planned by a planning consultant or structural expert. Structural damage due to earthquake can be divided into non-structural damage and structural damage. Non-structural damage is damage that occurs in non-structural parts of the building, such as detached wall plaster, cracked or broken brick walls and damaged ceilings. Structural damage is damage that occurs to the main elements of the building structure, such as cracks in the columns, plates or beams, the detachment of the concrete cover of the beam/column or the breaking of the head or bottom of the column. This structural damage can be seen in Figure 2, where it can be seen that there is poor reinforcement detailing.

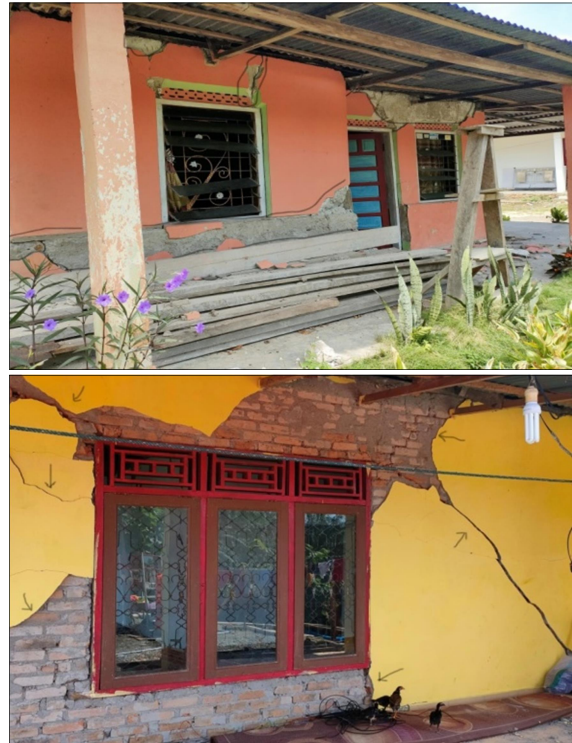
1. Damage to the walls of the house, which is shown from the front view (Figure 4),
2. damage to the wall and column structure, which is shown from the side view (Figure 5),
3. buildings that are damaged on the walls. The wall suffered from cracks and also the plaster of the damaged wall was quite extensive and fell due to the energy of the earthquake waves (Figure 5),
4. buildings damaged by the earthquake occurred on the columns, truss, and walls (Figure 6),
5. building damage that occurred in the column, cracked and collapsed walls (Figure 6), and
6. buildings that were damaged by earthquakes in all building structures, damage to walls, floors, roofs, window frames, doors, and houses did not use a column structure, only using wooden beams as support poles. Under these conditions, the building becomes uninhabitable and cannot be repaired,

Figure 4. Damage to the wall

No	Elements of structure	Number of damage	Level of Damage (%)
1	wall (Figure 4)	Number coloumn (DT) = 105 cm <sup>2</sup> Damage element (QD) = 24,5 cm <sup>2</sup>	Level = 24,5/105*100%=24,5% < 30% → <b>Low damage</b>
2	Wall & coloumn (Figure 5)	Total wall area (LT) = 126 cm <sup>2</sup> Damage element (QD) = 19,8 cm <sup>2</sup>	Level=19,8/126*100%=15,7% < 30% → <b>Low damage</b>
3	Coloumn & ring beam (Figure 5)	Numbercoloumn+ring beam=10+4=14 Number coloumn +ring beam damage = 1	Level = 1/14*100% = 7,1% < 30% → <b>Low damage</b>
4	Element wall (Figure 4)	Total wall area = 133 m <sup>2</sup> Damage element = 35 m <sup>2</sup>	Level = 35/133*100% = 26% < 30% → <b>Low damage</b>
5	Wall element (Figure 5)	Total wall area = 162 cm <sup>2</sup> Damage element = 52 cm <sup>2</sup>	Level = 52/162*100 = 32,5% → <b>Moderete damage</b>
6	Wall element (Figure 6)	Total wall area = 176 cm <sup>2</sup> Damage element = 60 cm <sup>2</sup>	Level = 60/176*100 = 34,09% → <b>Moderete damage</b>

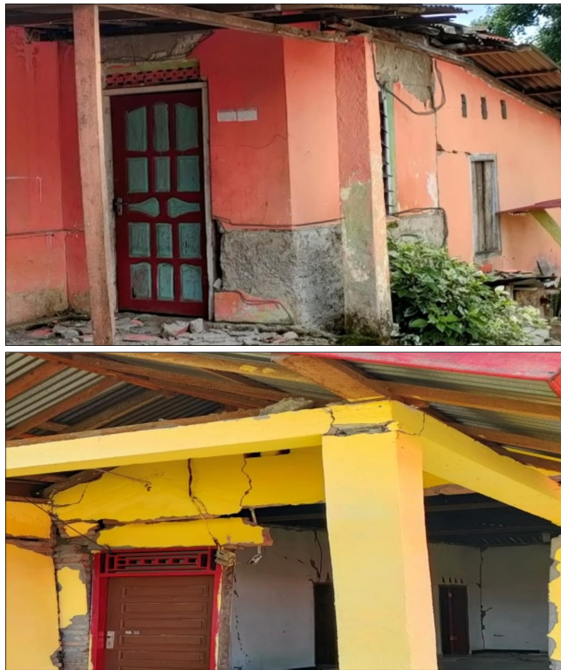
Figure 5. Damage to walls and column structures

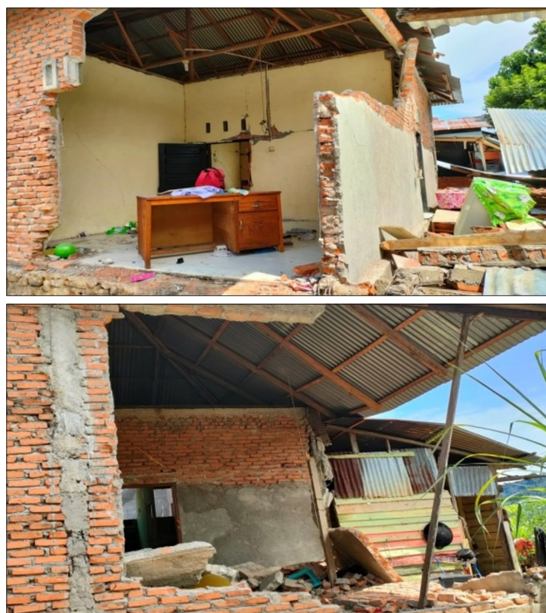
Figure 6. Damage to columns, walls cracked and collapsed

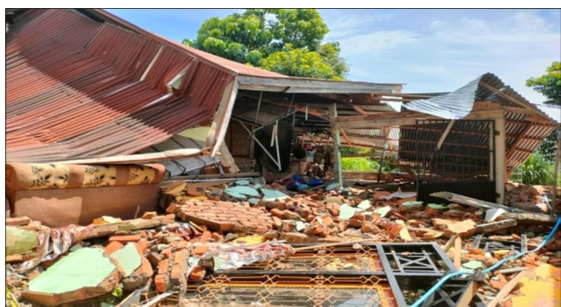
because the structure has been completely damaged, so the building must be rebuilt by following the applicable standard procedures (Figure 7).

7	Wall element (Figure 7)	Total wall area = 119 cm <sup>2</sup> Damage element = 80 cm <sup>2</sup>	Level = 80/119*100 = 67,22% > 65% → <b>High damage</b>
8	door, sill, window (Figure 7)	Number of door = 6 total number sill + window = 14 cm <sup>2</sup> Number of door, sill, number of damage = 11	Level = 11/14*100 = 78,6% > 65% → <b>High damage</b>
9	Floor (Gambar 8)	Total area floor =72 cm <sup>2</sup> Damage floor area = 36 cm <sup>2</sup>	Level = 36/72*100 = 50% > 50% → <b>High damage</b>
10	Penutup atap (Gambar 10)	Total area = 144 cm <sup>2</sup> Damage element = 144 cm <sup>2</sup>	Level = 144/144*100 = 100% > 65% → <b>High damage</b>
11	Rangka atap (Gambar 8)	Total area = 144 cm <sup>2</sup> Damage element = 144 cm <sup>2</sup>	Level = 144/144*100 = 100% > 65% → <b>High damage</b>

Figure 7. Total damage to the house
