## Identification Of Damage Levels Of Residents' Houses Due To Earthquake in Pasaman 2022

### Abstract

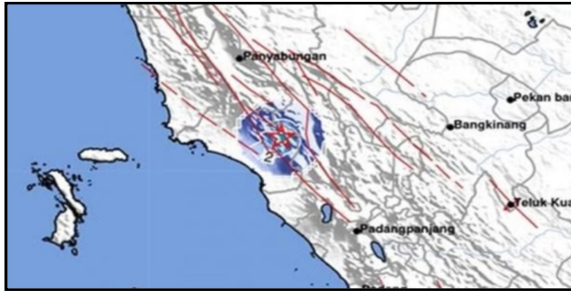
The Meteorology, Climatology and Geophysics Agency (BMKG) has found a new fault segment in West Sumatra. Previously in the Pasaman area, which frequently affected the earthquake in that area were the Ancora and Sianok faults. But now a new fault segment has been found, namely the Talamau fault, as shown in Figure 1. This fault is classified as a right-hand shear fault, which is a characteristic of the seismic mechanism of the Sumatra fault.

Figure 1. Talamau fault segment
